**WETLAND DELINEATION REPORT
FOR
PORTIONS 1-187 (OF REM) OF THE FARM ALICAVILLE NO. 2147**

Date: 31 November 2014

Prepared for:
Chris Le Seuer
Zamori 129 (Pty) Ltd
110a Crompton Street
Pinetown
Chris@venturepartners.co.za

By:
Warren Botes (MSc Environmental Sciences)
[wbotes@gmail.com](mailto:wvotes@gmail.com)
0837981974

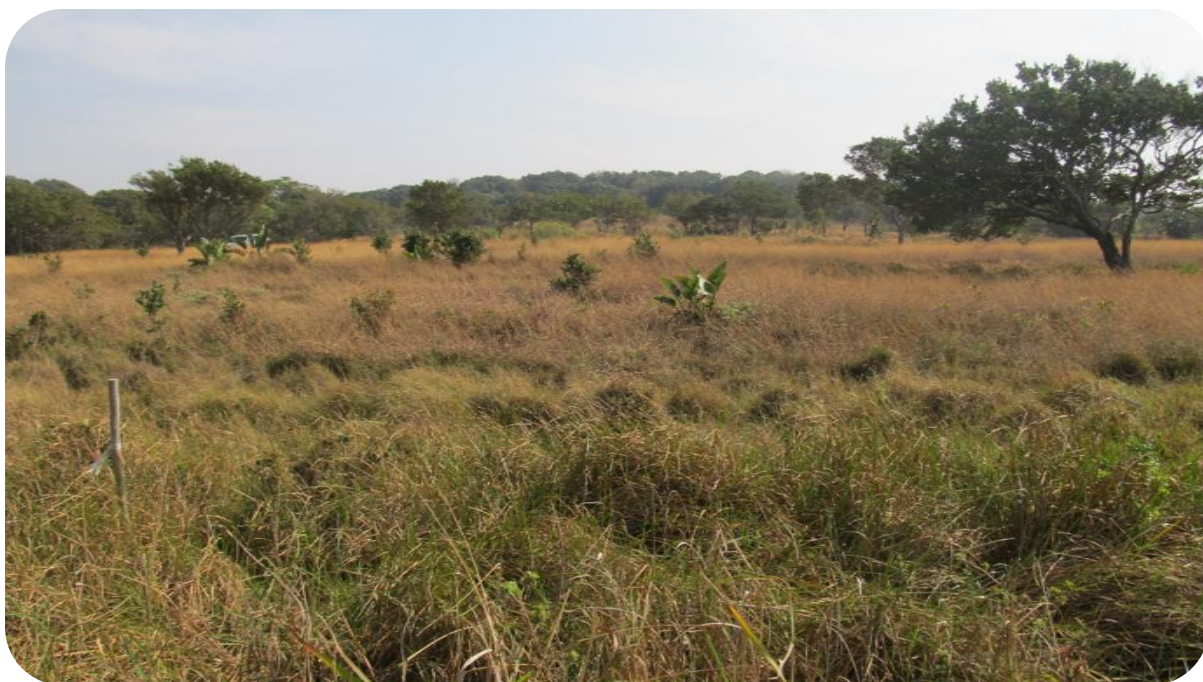
Plate 1: A photograph of the site looking westwards across Minerva Road.

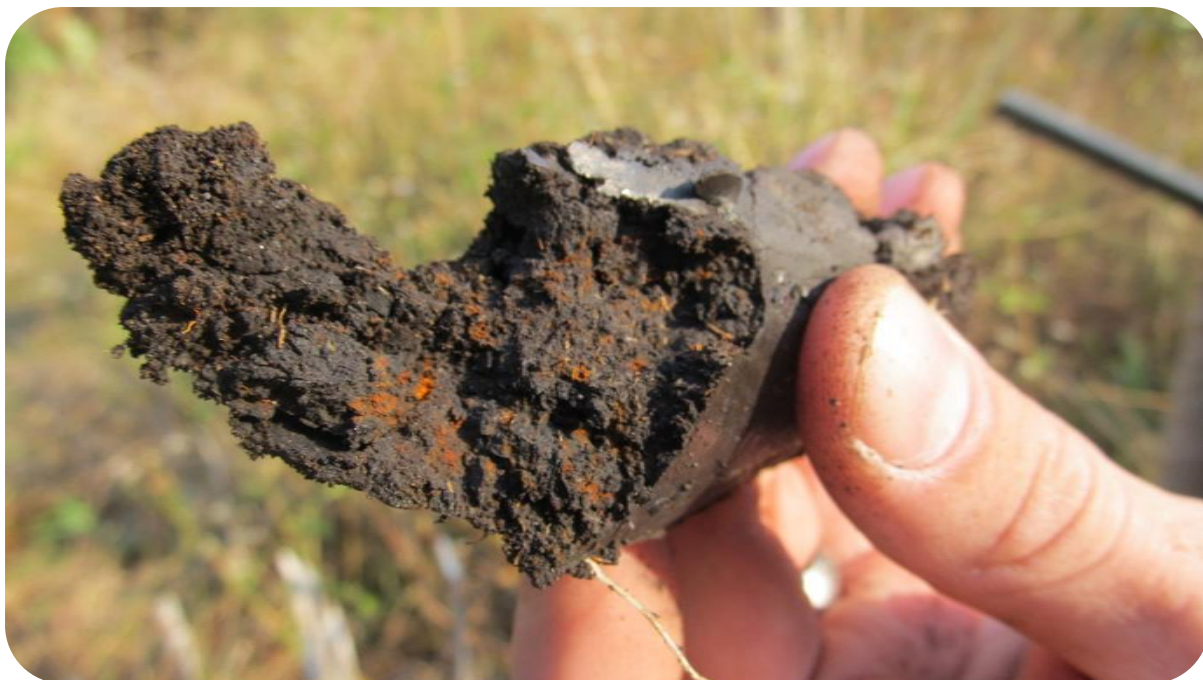
Plate 2: Soil sample taken within the wetland area at the site. Note the dark grey matrix and distinct orange mottles.

As the site is relatively undisturbed by recent agricultural activity, the soils across the site were found to be a good indicator of wetland presence. Sticky, black to grey, organic rich sands and dark brown, silty sand both with either feint or distinct orange to red mottling, indicated temporary and seasonal wetlands (Plate 2). Heavier gleyed clays and silty sands indicated the more frequently wet and permanently wet areas.

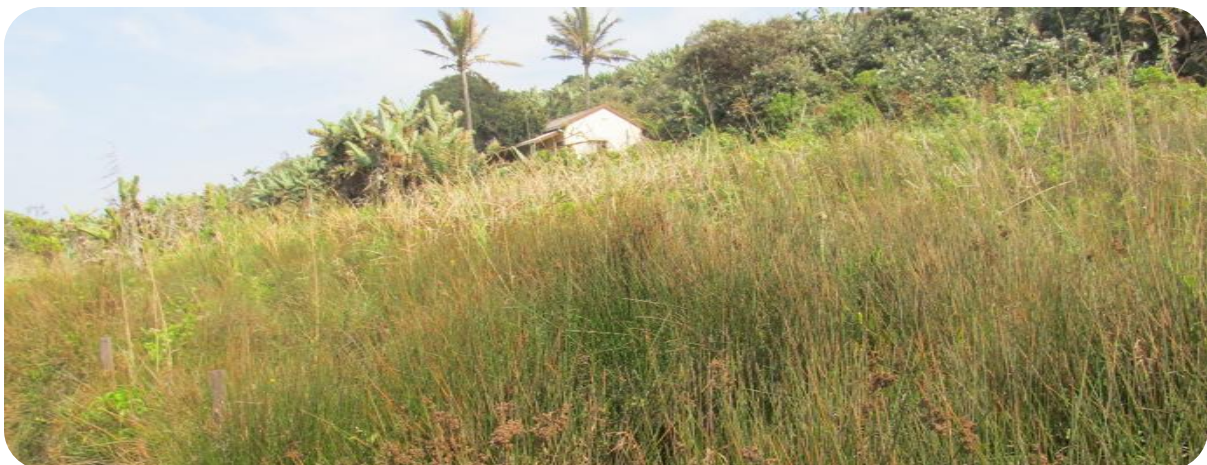
The vegetation of Area A (Figure 1) was dominated by *Typha capensis*, *Juncus kraussii*, and *Phragmites australis*. *Kniphofia sp.* was also noted in this area.

Plate 2: The vegetation of Area A (Figure 1).

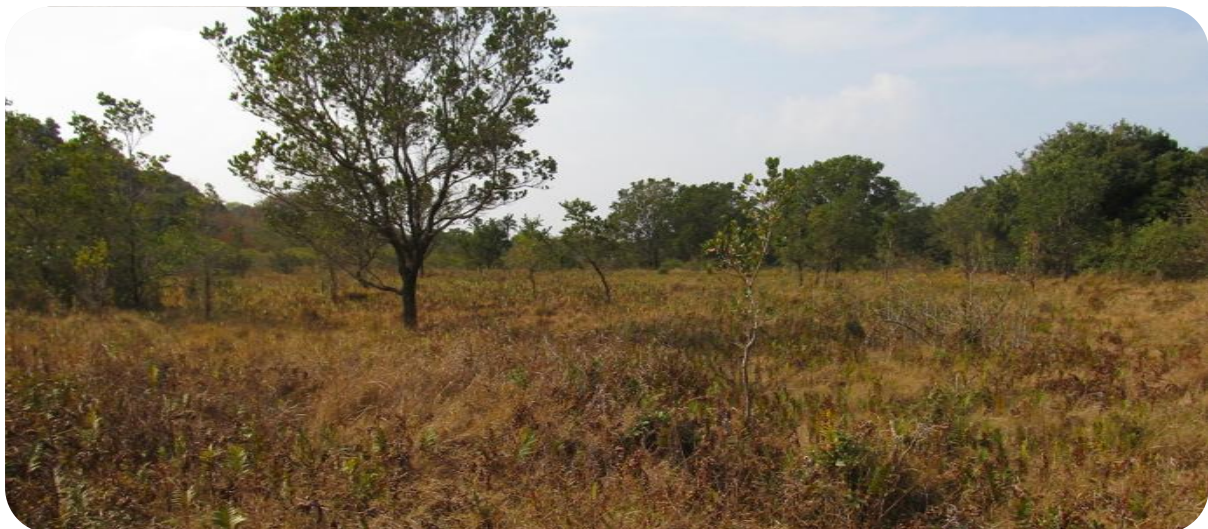
The vegetation found at valley head at D was dominated by sedges and grasses with the fern *Nephrolepis biserrata* being widely distributed throughout the seasonally wet areas. *Syzygium cordatum* was also common in this area. An alien shrub species which appears to be a member of the *Tibouchina* genus was also common throughout this area.

Plate 3: The vegetation of Area D (Figure 1).

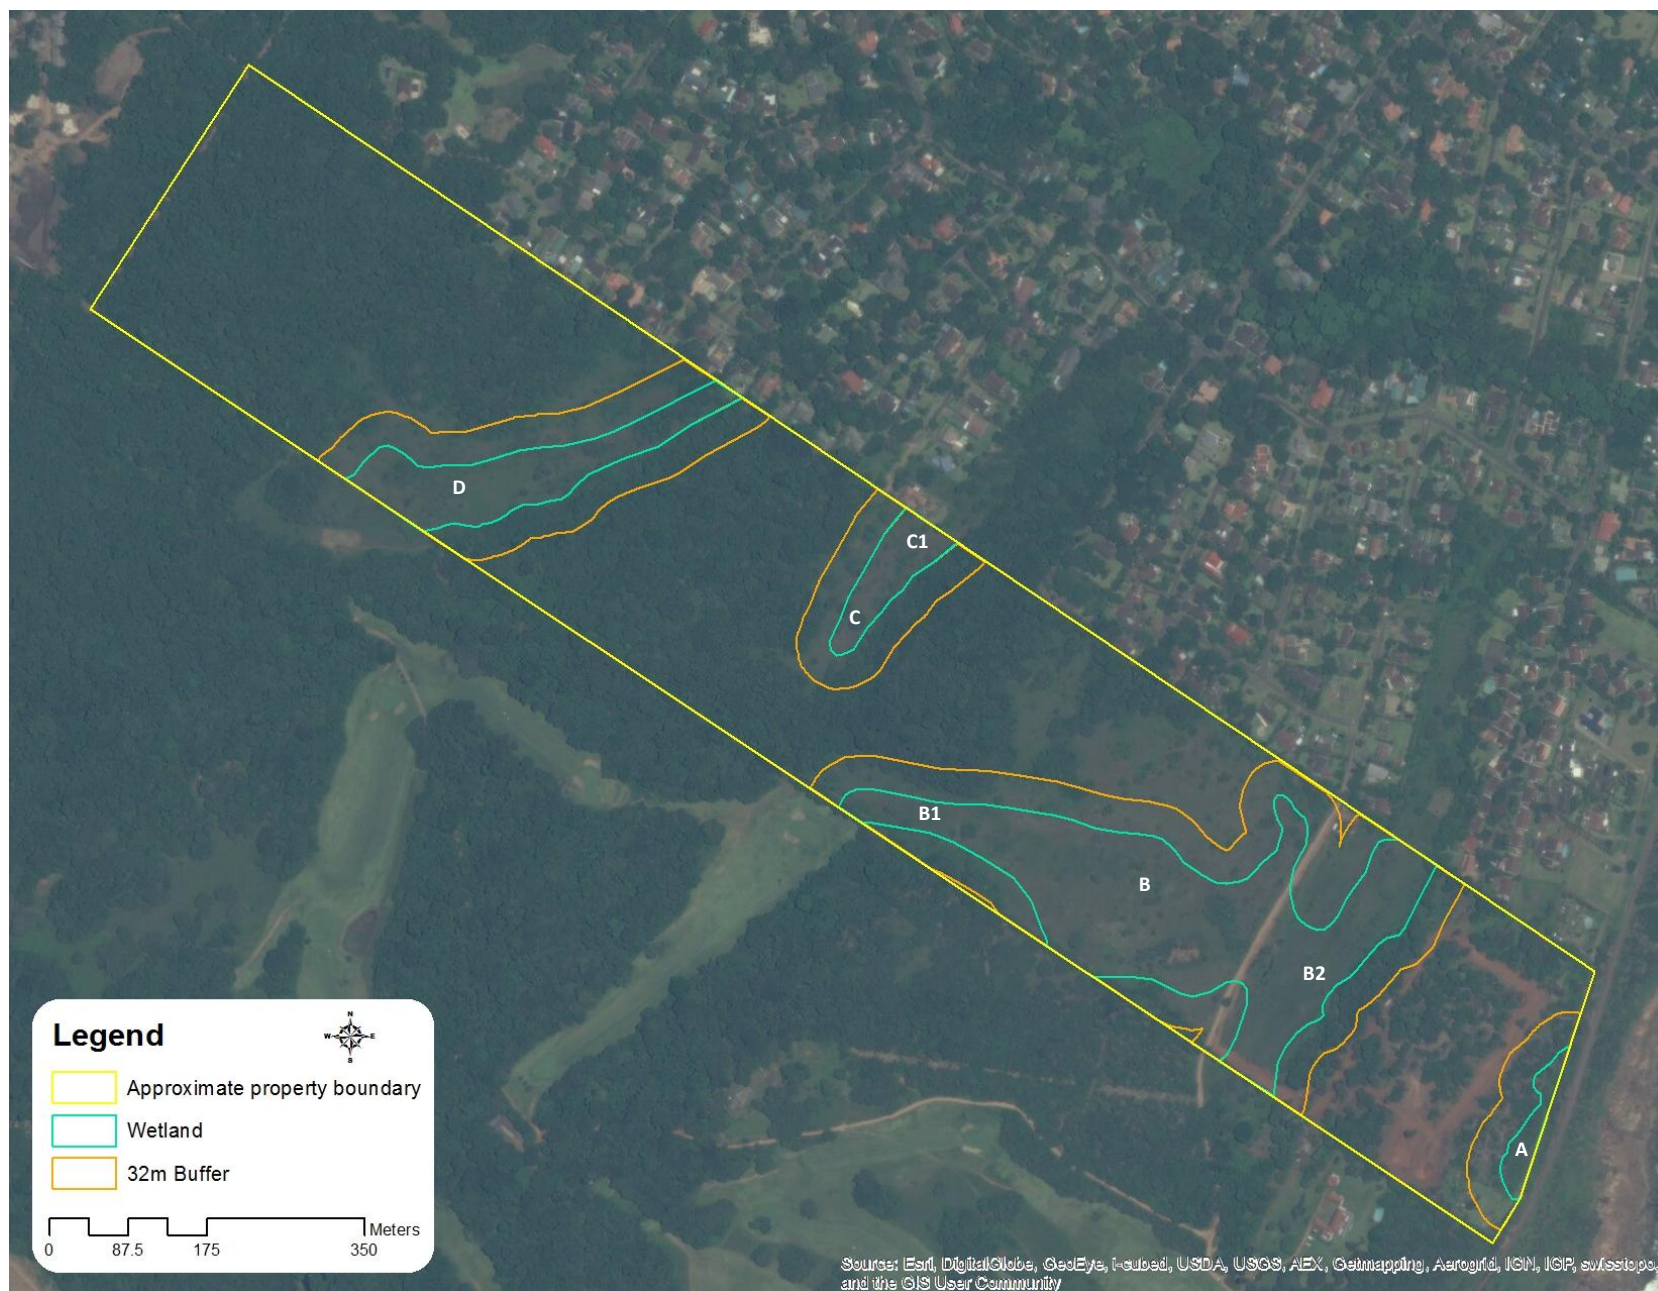
The soils showed that a small patch of the primary dune immediately west of the railway (A in Figure 1) is seasonally wet forming a hillslope seepage wetland. The soils in this area were generally grey sands with distinct orange mottling.

Large parts of the upper east facing slope, (B in Figure 1) were found to be temporarily or seasonally wet while the lower parts closer to Minerva Road, were found to be seasonally to permanently wet. In the valley bottom soils were dark brown to dark grey sand clays or silts with orange to red mottling indicating seasonal wetness.

The smaller valley head (C in Figure 1) also had elements of hillslope seepage on the east facing slope indicated by dark brown to black silty sand with orange mottling. The bottom of the valley had soils that were stickier due to higher proportions of fine sediments but still had mottling indicating seasonal wetness.

The flatter valley head, (D in Figure 1) had soils characteristic of seasonal wetland, with dark grey to brown sandy silts with orange to red mottling of varying degrees.

The vegetation of Area B (Figure 1) was found to be characteristic of larger coastal hillslope seepage wetlands being dominated by sedges such as *Cyperus sphaerospermus* and hydrophytic grasses such as *Ischaemum fasciculatum*. Also common on this slope was *Syzygium cordatum*. Seasonal to

permanently wet areas were indicated by species such as *Fimbristylis sp.* and *Eleocharis sp.* with some large *Syzygium cordatum* individuals at the top of the slope (at B1 in Figure 1) and *Cyperus latifolius* lower down the slope (at B2 in Figure 1).

Valley head C has vegetation dominated by grass species such as *Aristida junciformis* and *Cymbopogon validus* while certain patches of the east facing slope (C1 in Figure 1) was dominated by *Ischaemum fasciculatum* indicating slightly longer periods of wetness.

Figure 1: A map of the wetland area on the site showing the boundary of the wetlands as well as a 32m buffer.

The results reveal four distinct hydrogeomorphic (HGM) units on the site. Most of these HGM units appear to be strongly controlled by seepage and ground water with units labelled as A, B and B1 in Figure 1 being characteristic of Hill Slope Seepage wetlands. B2 was more similar to an Unchannelled Valley Bottom wetland. Areas C and D were classified as Unchannelled Valley Bottom wetlands with elements of Hill Slope Seepage.

A significant area of 'new' wetland, not recorded in the original 2005 wetland report, including an additional HGM unit (shown as D in Figure 1) has been noted. The primary reason for this may be changes in hydrological conditions on the site, either because alien plants have been removed (as part of site management by the developer) or because of recent high rainfall, which has "activated" previously "dormant" wetlands and facilitated a change in the extent of wetland associated vegetation. Wetland sampling strategies are often guided by vegetation as initial indicators of the presence of possible wetlands. It may have been a case where a period of dry years or the alien plants contributed to a drop in the water table of the site and a resultant shift in vegetation species to terrestrial types, and these areas were consequently and reasonably overlooked in 2005. A significant amount of water runoff was noted within Wetland unit A. Considering that 2014 sampling was undertaken at the end of a dry winter season, the water source may well be a leaking pipe. Pipe infrastructure was noted in close proximity to this system and should be investigated as a possible water source.

Although impacted by past disturbance, such as the construction of Minerva Road, the wetlands on the site appear to be in good condition with characteristic zonation of species and low levels of alien invasion in most cases. The wetland area labelled D in Figure 1 is, however, extensively invaded by what appears to be *Melastoma malabathricum*. Most of the wetlands are likely to be important from an ecosystem function and habitat provision perspective as large tracts of natural vegetation are becoming increasingly rare along the KwaZulu-Natal coast. The wetlands are also likely to be important from a stream flow maintenance perspective, however most of the watercourses into with these wetlands drain have been canalized, and are likely to have a very low biodiversity value. Therefore it is likely that the most important function that these wetlands perform is habitat provision.

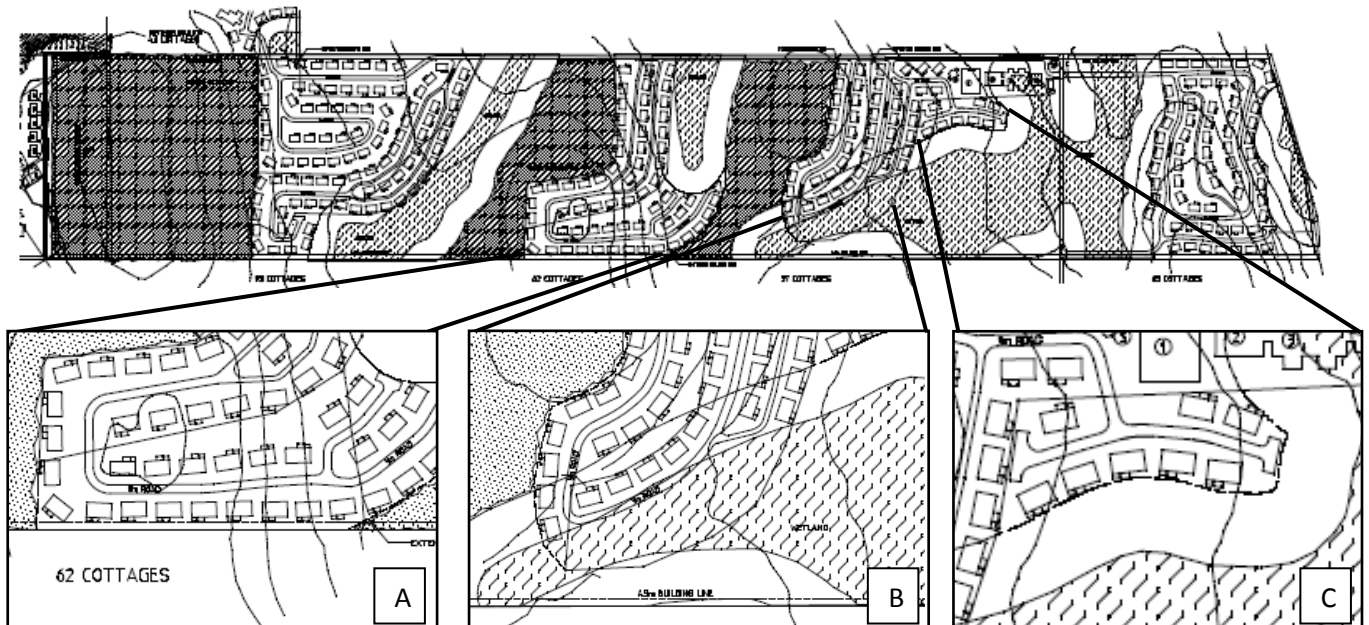
The applicant presented an alternative layout (Figure 2) and requested feedback on the suitability and possible positive and negative aspects of the changes. The key changes are highlighted in Figure 2 A, B and C.

Figure 2: Proposed alternative layout with key amendments highlighted in A, B and C.

- (A) The amended layout includes an increase in the footprint and number of units in the south-central section of the site, in close proximity to wetland C and C1 (Figure 1). These units are not located within the wetland or associated buffer and, therefore, will not impact directly on wetland. The increase in density will, however, modify the hydrology and possibly increase runoff intensity. This, if not managed properly, may lead to degradation of the system through scouring and erosion.

- (B) The original approved layout included units that would be located within the upper section of wetland B1 (Figure 2). Construction of these units would have resulted in direct loss of a significant portion of wetland B1 and, considering the location at the top of the system, would have limited water flow into wetland B, seriously compromising its functionality. The retraction of units out of the core wetland area will, therefore, avoid direct loss of wetland B1 and have less impact on the hydrology of wetland B.

- (C) In order to compensate for the removal of units described in amendment (B), the applicant has proposed to relocate these to a north-east area of the site. As with amendment A, these units are located outside of the wetland and associated buffer but the increased density may affect runoff intensity into wetland B. That said, when comparing this amendment to the original layout. The increased density outside of the wetland and buffer is much more desirable than the loss of wetland B1 and the modification of flow into wetland B.

When looking at this proposal from a holistic perspective, the cumulative impact is likely to be reduced in comparison to the original approved development, in that wetland destruction is avoided, water flow is not impeded and relocation of units is outside of the wetland and buffer

areas. The increased density should be mitigated through the use of an appropriate Stormwater Management Plan that focuses on maintaining natural hydrological regime of the wetland.

The applicant has proposed an alternative layout to that which was approved. The amendments are likely to result in a net reduction in the impact on the wetlands compared to the previously approved layout, especially wetlands B1 and B. The proposed increase in densities will, however, impact on the hydrology of the catchment and appropriate measures, such as an appropriate Stormwater Management Plan, should be employed to mitigate impacts on the adjacent systems.
